Grantham Floods Commission of Inquiry

Report

October 2015

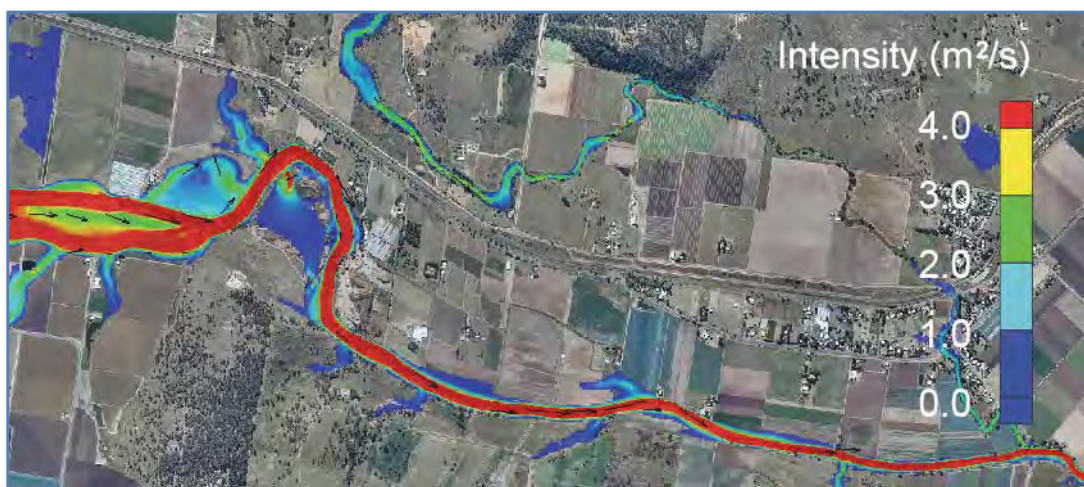
Figure 5.13: Image of modelled water levels at 3:25 pm on 10 January 2011
Source: Exhibit 144, John Macintosh, Most likely scenario animation

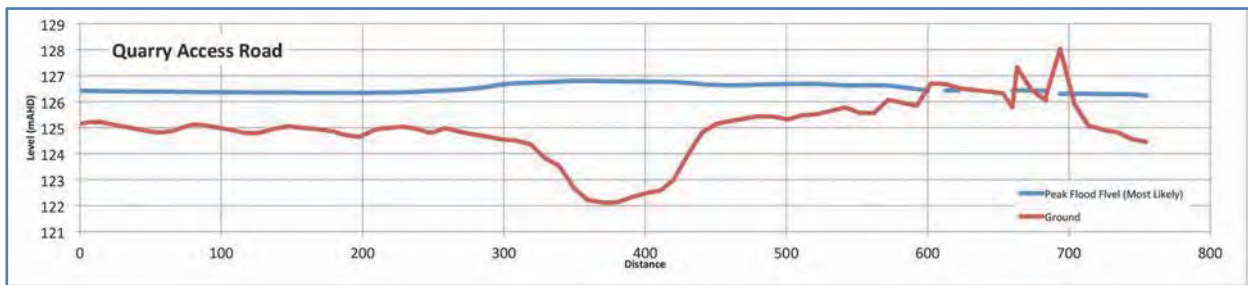
Figure 5.17: Cross-section from north to south along Quarry Access Road
 Source: Exhibit 162, Dr John Macintosh, Cross-section – western overbank breakout sections.

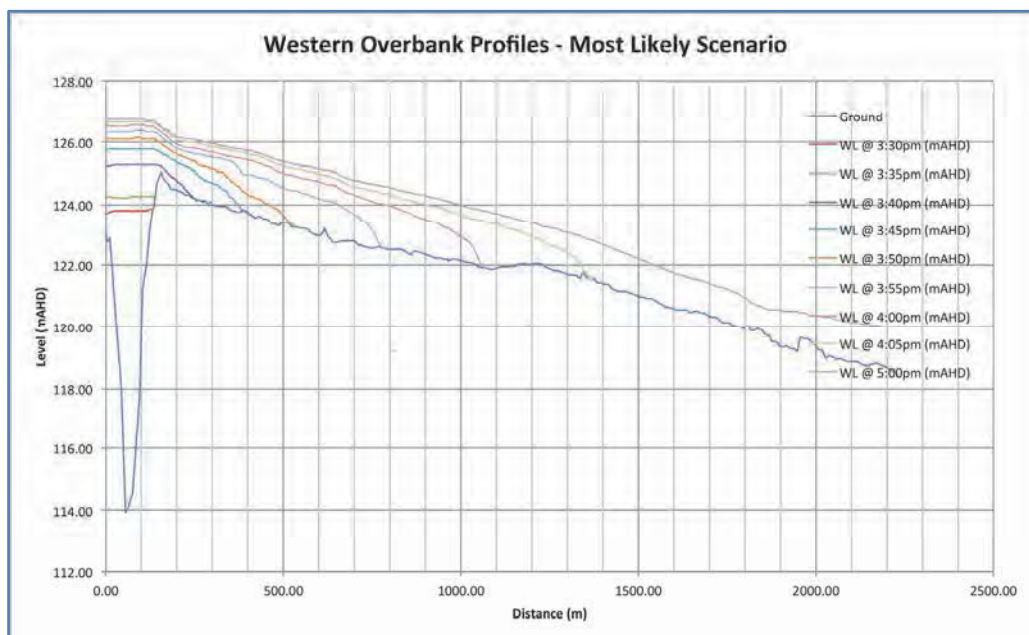
Figure 5.18: Western overbank flow profiles
 Source: Exhibit 159, Dr John Macintosh, Western Bank profiles

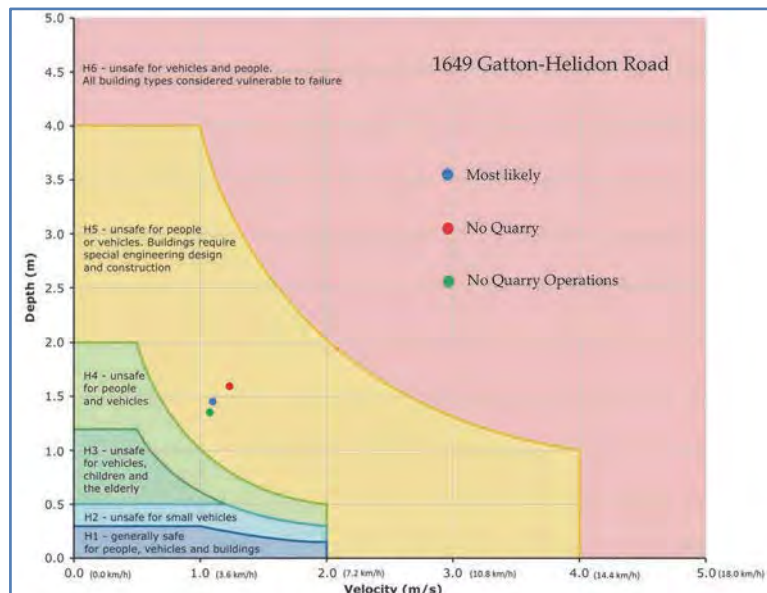
Figure 5.28: Depth, velocity, intensity and hazard at 1649 Gatton-Helidon Road

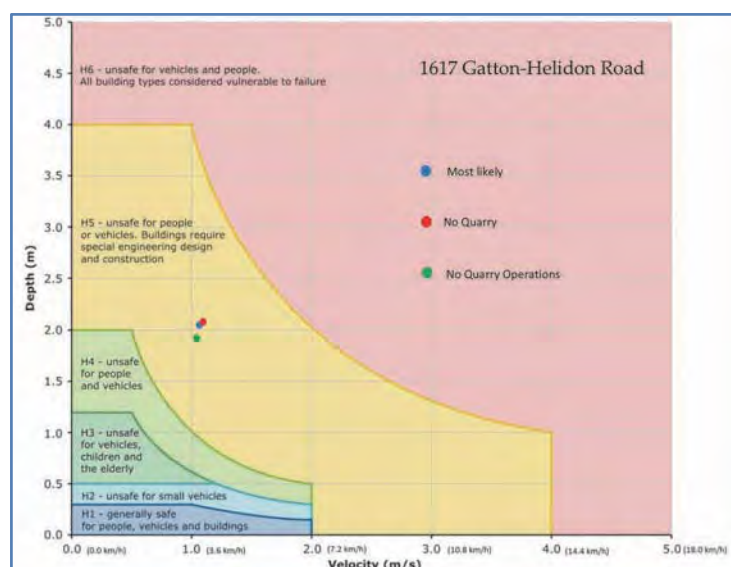
Figure 5.29: Depth, velocity, intensity and hazard at 1617 Gatton-Helidon Road
 Source: Exhibit 142, Grantley Smith, *Expert Opinion: Stability of People, Vehicles and Buildings in Flood Water*, 13 August 2015 [p6: Figure 3] (amended)

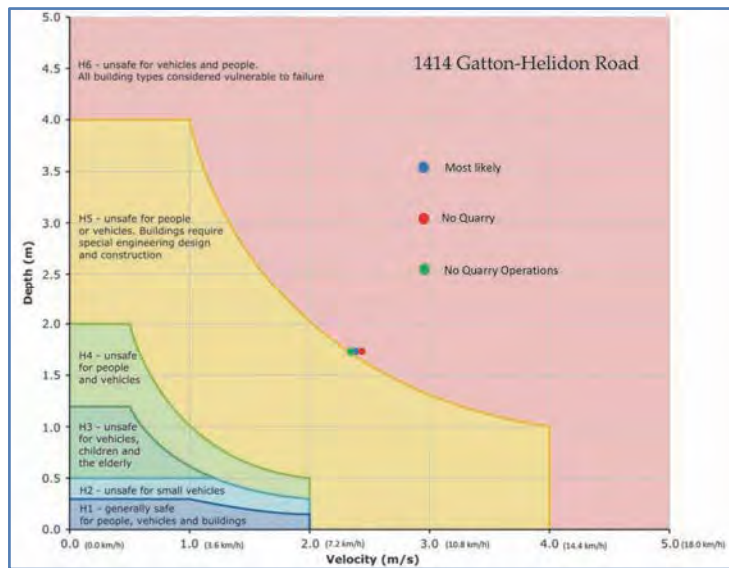
Figure 5.30: Depth, velocity, intensity and hazard at 1414 Gatton-Helidon Road
 Source: Exhibit 142, Grantley Smith, *Expert Opinion: Stability of People, Vehicles and Buildings in Flood Water*, 13 August 2015 [p6: Figure 3] (amended)

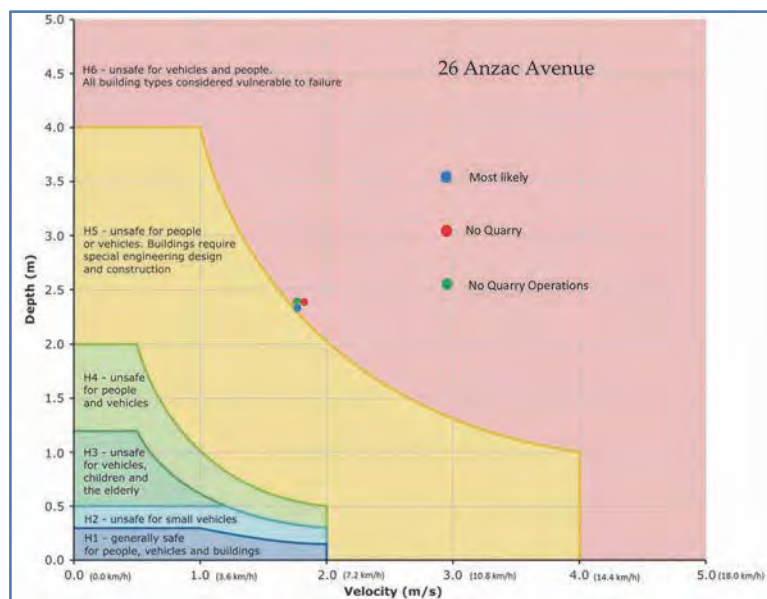
Figure 5.31: Depth, velocity, intensity and hazard at 26 Anzac Avenue
 Source: Exhibit 142, Grantley Smith, *Expert Opinion: Stability of People, Vehicles and Buildings in Flood Water*, 13 August 2015 [p6: Figure 3] (amended)

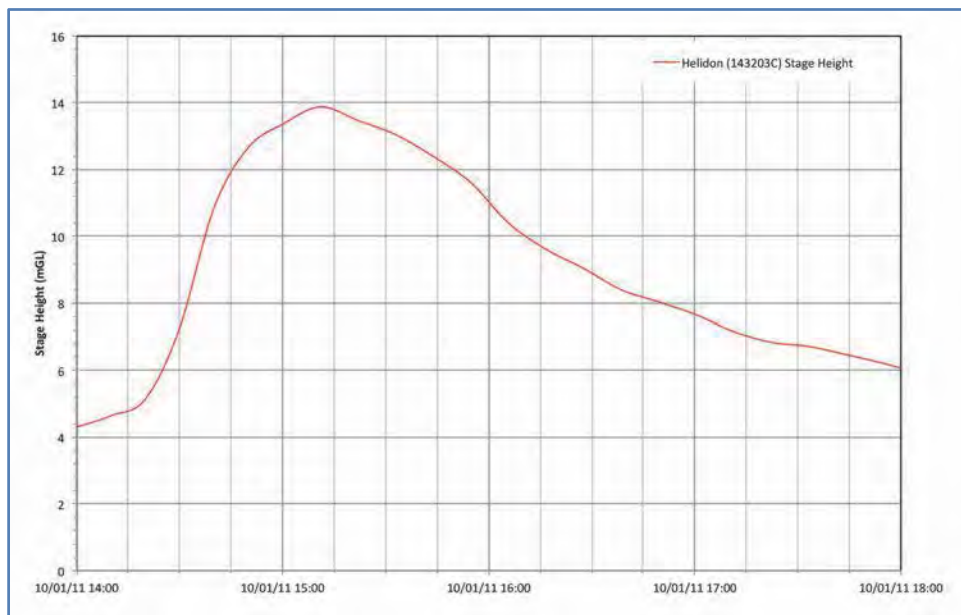
Figure C3: Hydrograph for Helidon stream gauging station on 10 January 2015.

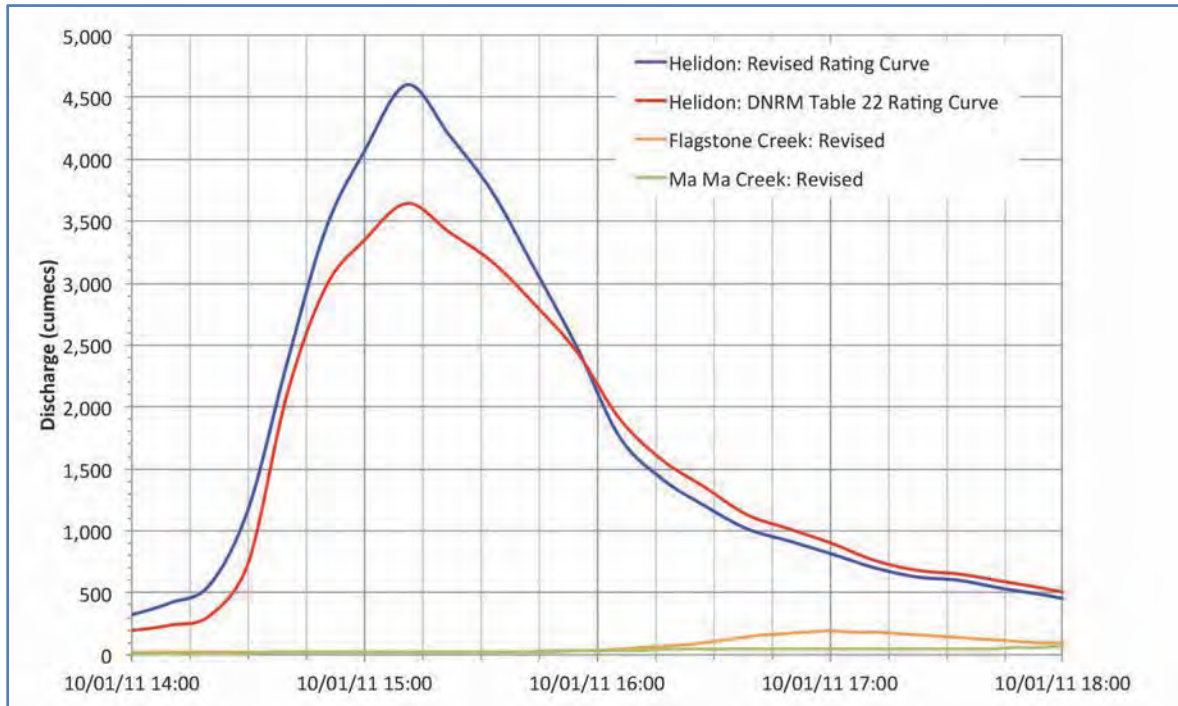
Figure C5: Final hydrographs used by Dr Macintosh.

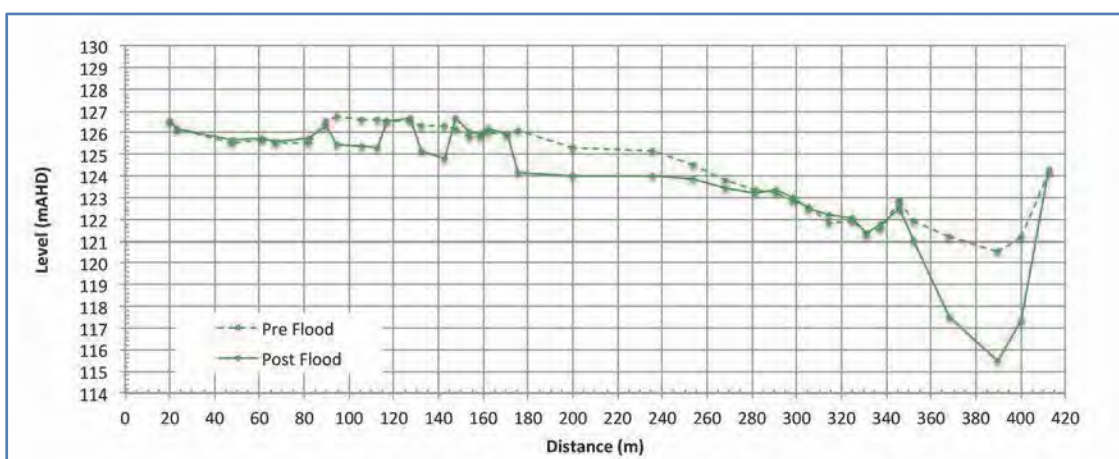
Figure C7: Western bund profiles for pre and post flood conditions.

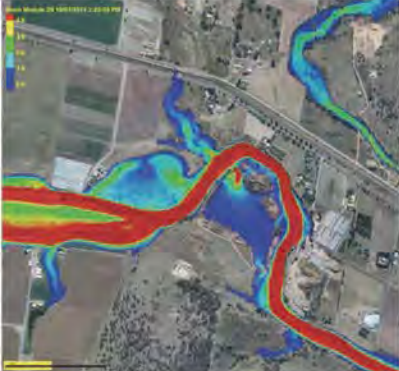
<p>(e) 3:25pm</p> <ul style="list-style-type: none"> • Lockyer Creek has broken out upstream from the quarry. • “Oval” area upstream of quarry receiving inflow.

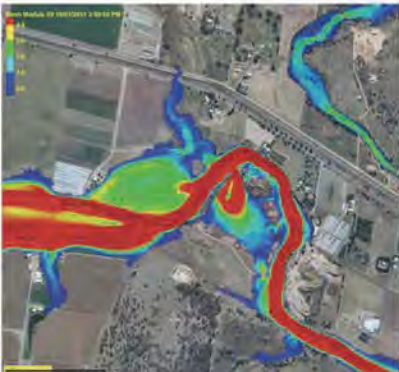
<p>(f) 3:30pm</p> <ul style="list-style-type: none"> • A marked increase in intensity of spill into the quarry associated with further erosion of the Main Breach. • Flow depths and intensities upstream from quarry continue to increase. • The Main Breach in the Western Levee has initiated.

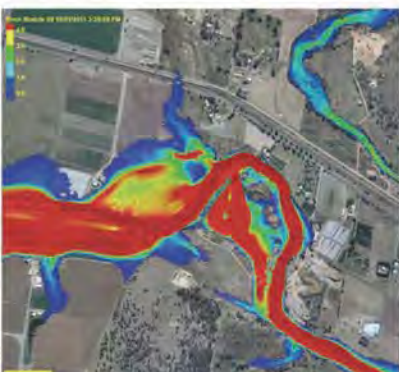
<p>(g) 3:35pm</p> <ul style="list-style-type: none"> • Commencement of outflow from the quarry through the south-eastern quadrant. • Breakout from Lockyer Creek at Quarry Access Road causeway commences with a rapid rise in local water levels. • Flow depths and intensities upstream from the quarry continue to increase.

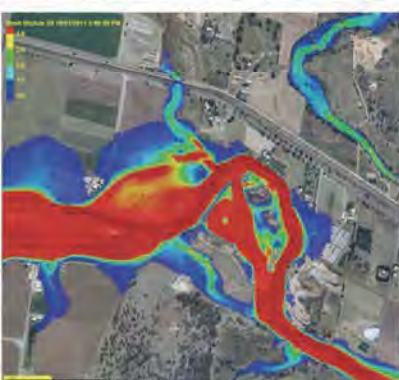
<p>(h) 3:40</p> <ul style="list-style-type: none"> • Failure of Main Breach complete. • Breakout from Lockyer Creek at Quarry Access Road causeway continues with a rapid rise in local water levels. • Full breaking out of the right overbank flow path to the south of the quarry. • Flow depths and intensities upstream from the quarry continue to increase.

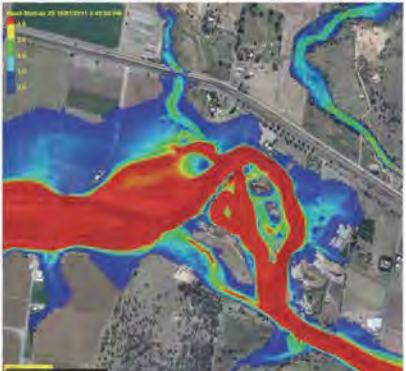
<p>(i) 3:45pm</p> <ul style="list-style-type: none"> • Breakout from Lockyer Creek at Quarry Access Road causeway continues with a rapid rise in local water levels. • Flow intensities starting to increase at the Quarry Access Road causeway breakout. • Full breaking out of the right overbank flow path to the south of the quarry. • Flow depths and intensities continue to increase throughout

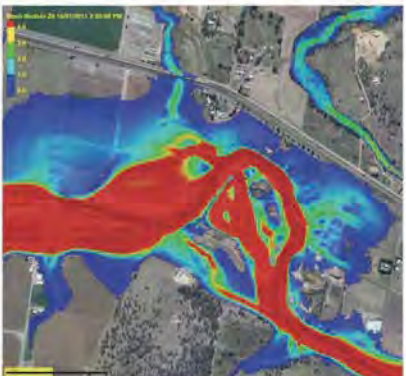
<p>(j) 3:50pm</p> <ul style="list-style-type: none"> • Initiation of erosion of the bunds in the Western Levee (other than in the area of the Main Breach). • Depth of water at 1615 Gatton-Helidon Road exceeds 0.3m (my estimated time of closure for evacuation purposes). • Flows commence along the Western Overbank flow path.

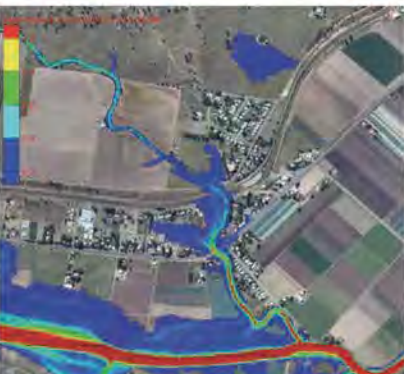
<p>(c) 3:55pm</p> <ul style="list-style-type: none"> Lockyer Creek has broken its banks with inundating flows rapidly approaching Grantham from the South-Western Overbank flow path. The Gatton-Helidon bridge over Sandy Creek has now been overtopped and within 1 minute the depth will exceed 0.3m (my estimated time of closure for evacuation purposes). This will result in closure of the last evacuation route for Western Grantham. Note that erosion of the Main Breach has completed. Note that erosion of the bunds in the Western Levee (other than in the area of the Main Breach) have commenced.

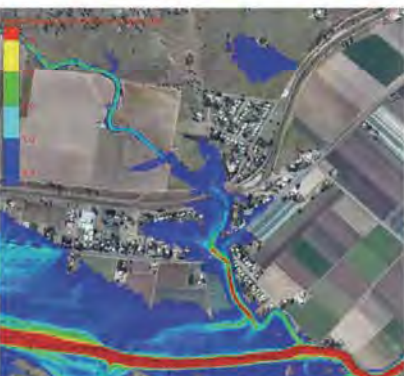
<p>(d) 4:00pm</p> <ul style="list-style-type: none"> Floodwater from Lockyer Creek over the South-Western Overbank flow path has overtopped the Gatton-Helidon Road in Western Grantham, but these floodwaters have not yet reached the road within Central Grantham. Sandy Creek surcharge is continuing to inundate Central Grantham, but not as quickly as it is occurring in Western Grantham.

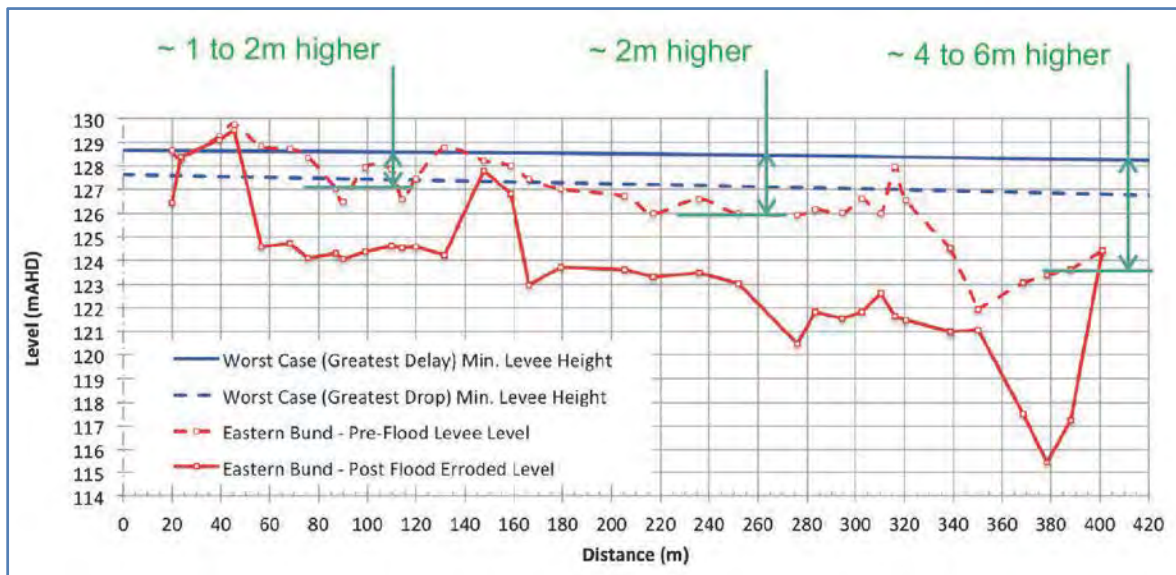
Figure C24: Profile through eastern bund with worst case bunds overlaid

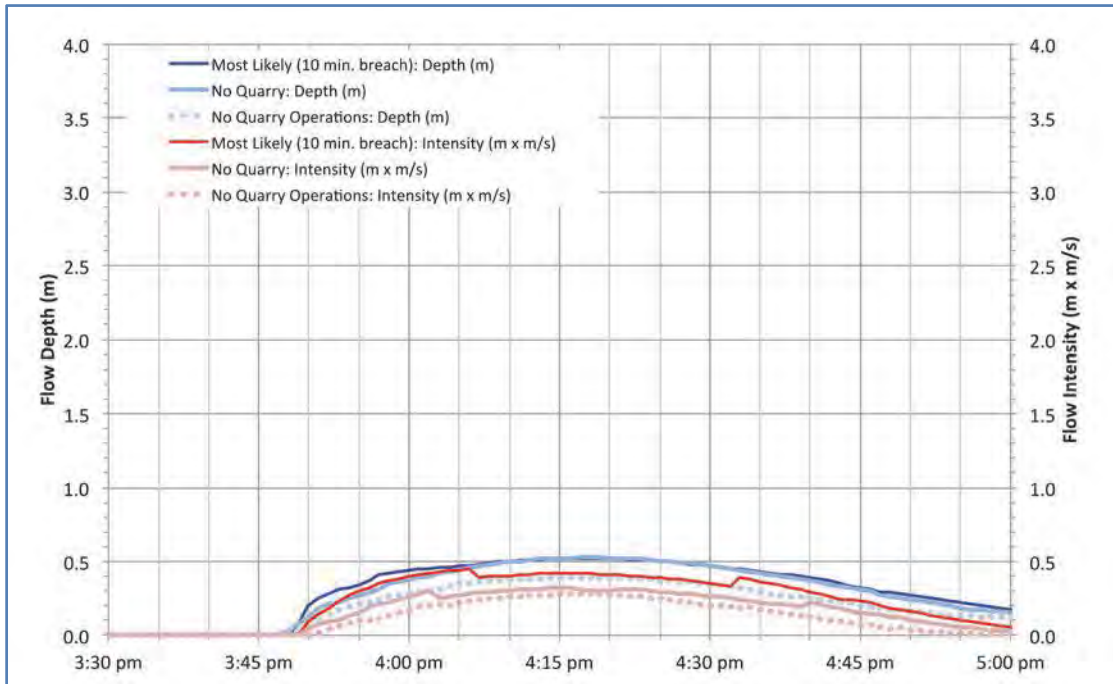
Figure C30: Comparison of flow depth and intensity at 1665 Gatton-Helidon Road

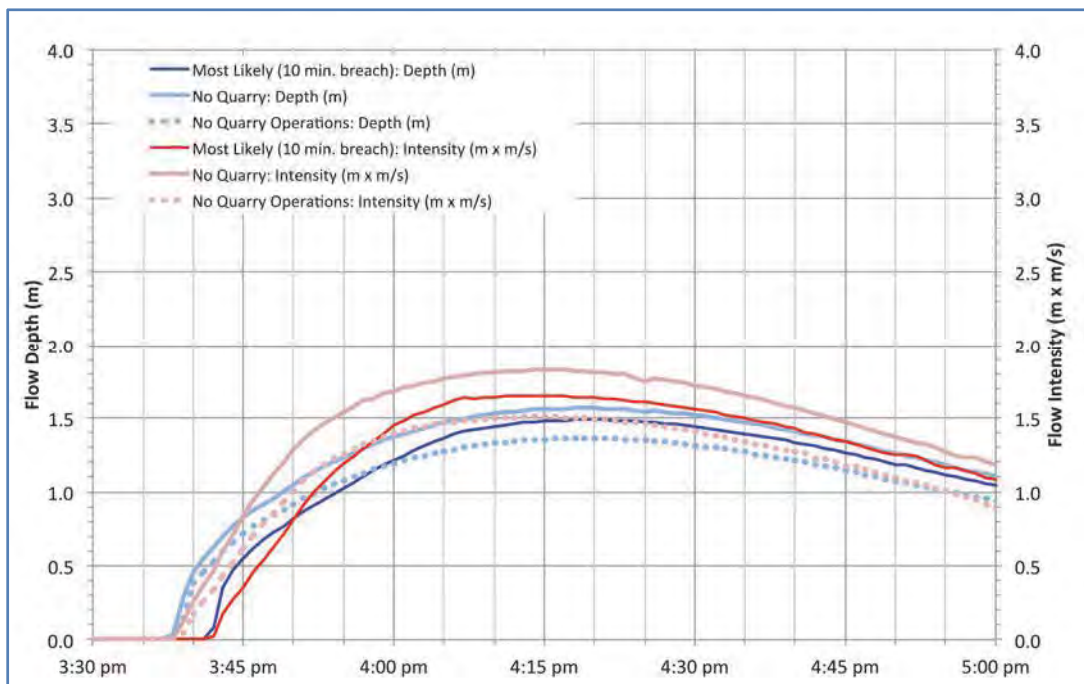
Figure C31: Comparison of flow depth and intensity at 1649 Gatton-Helidon Road

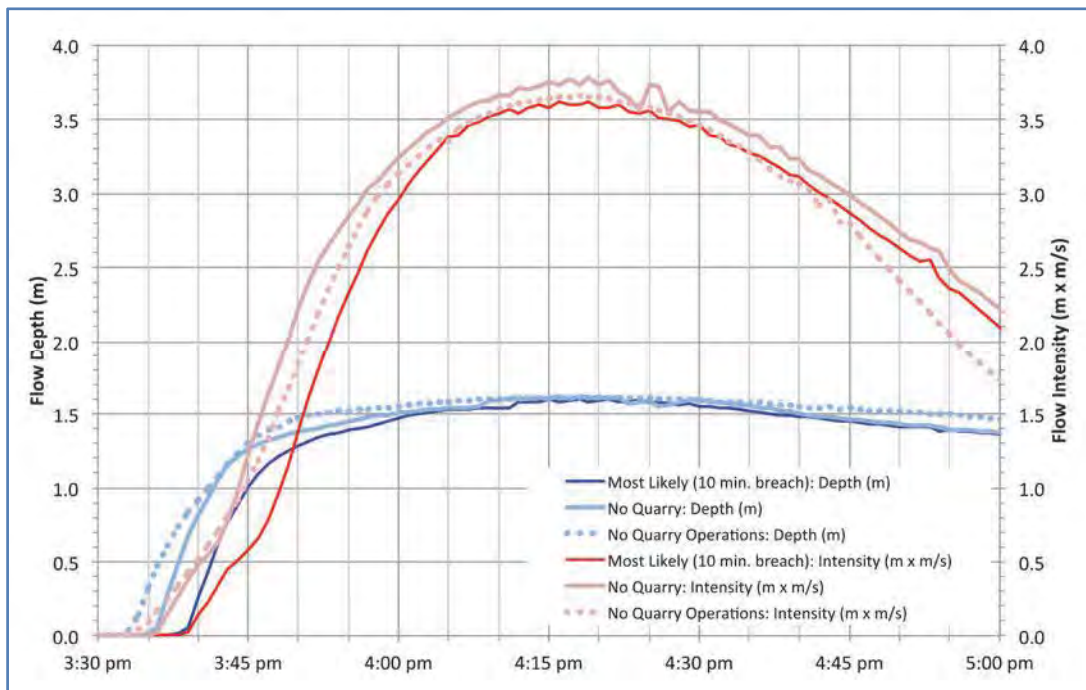
Figure C33: Comparison of flow depth and intensity at 1617 Gatton-Helidon Road

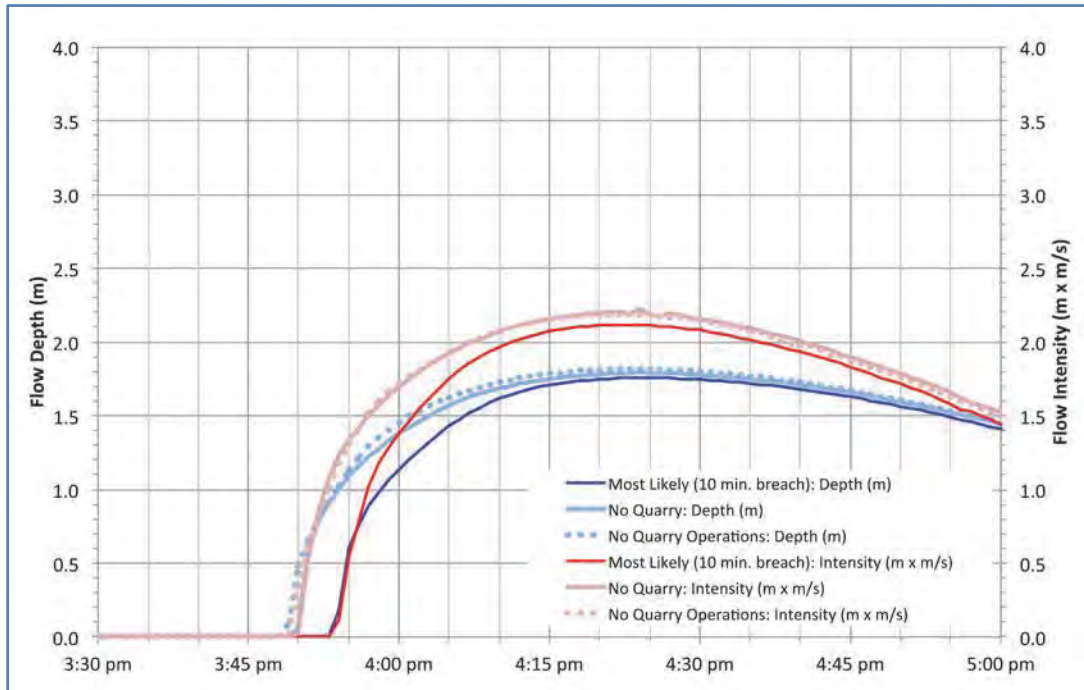
Figure C34: Comparison of flow depth and intensity at 27 Dorrs Road

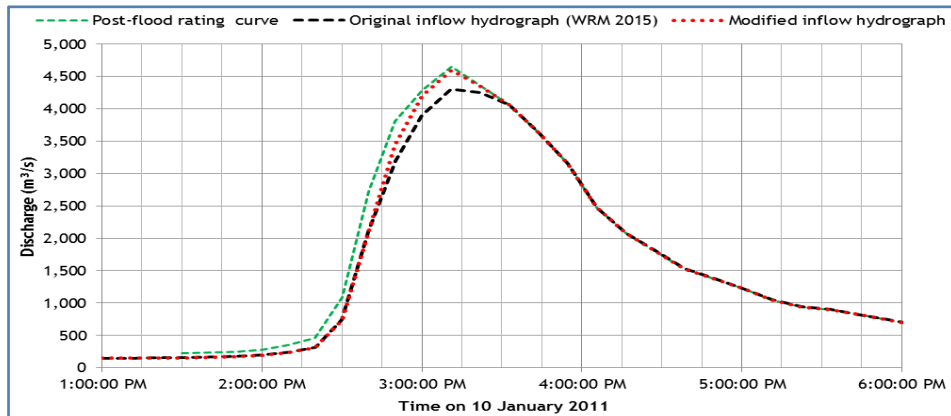
Figure C41: Inflow hydrograph.

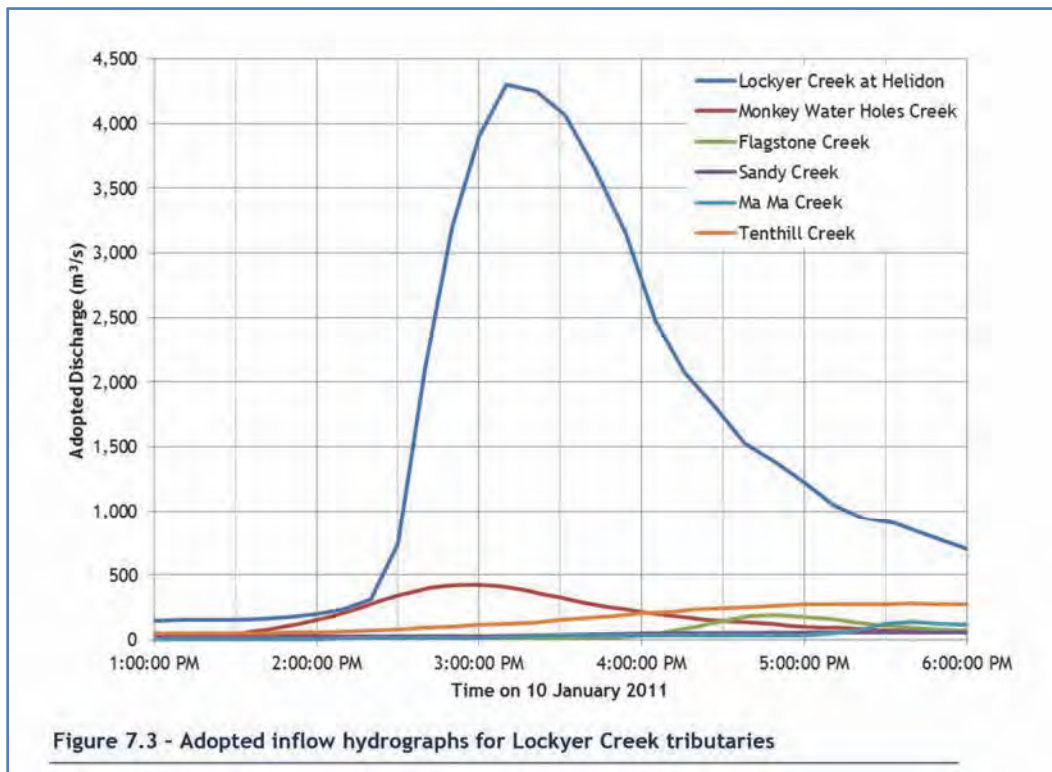
Figure C42: Inflow hydrographs for tributaries.

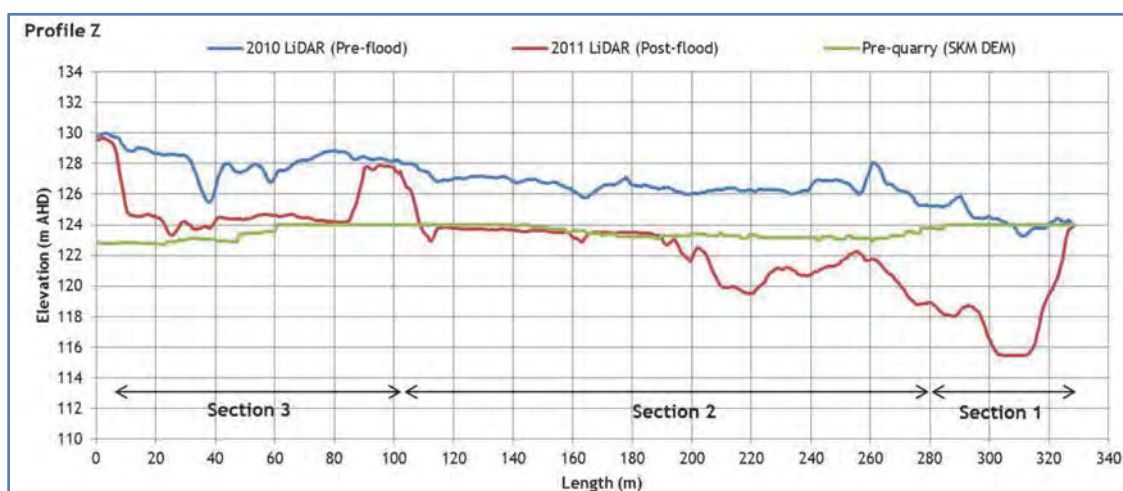
Figure C43: Cross section of western embankment.
